SOME IN-FIELD EXPERIENCES OF NON-SYNCHRONOUS VIBRATIONS  
IN LARGE ROTATING MACHINERY

Giuseppe Colnago  
CESI  
Via Rubattino 54  
20134 Milano, Italy

Claudio Frigeri, Andrea Vallini, and Gian Antonio Zanetta  
ENEL  
Via A. Volta 1  
20093 Cologno Monzese, Milano, Italy

The paper analyzes some problems associated with non-synchronous vibrations by describing three cases experienced with fairly large rotating machines in operating conditions.

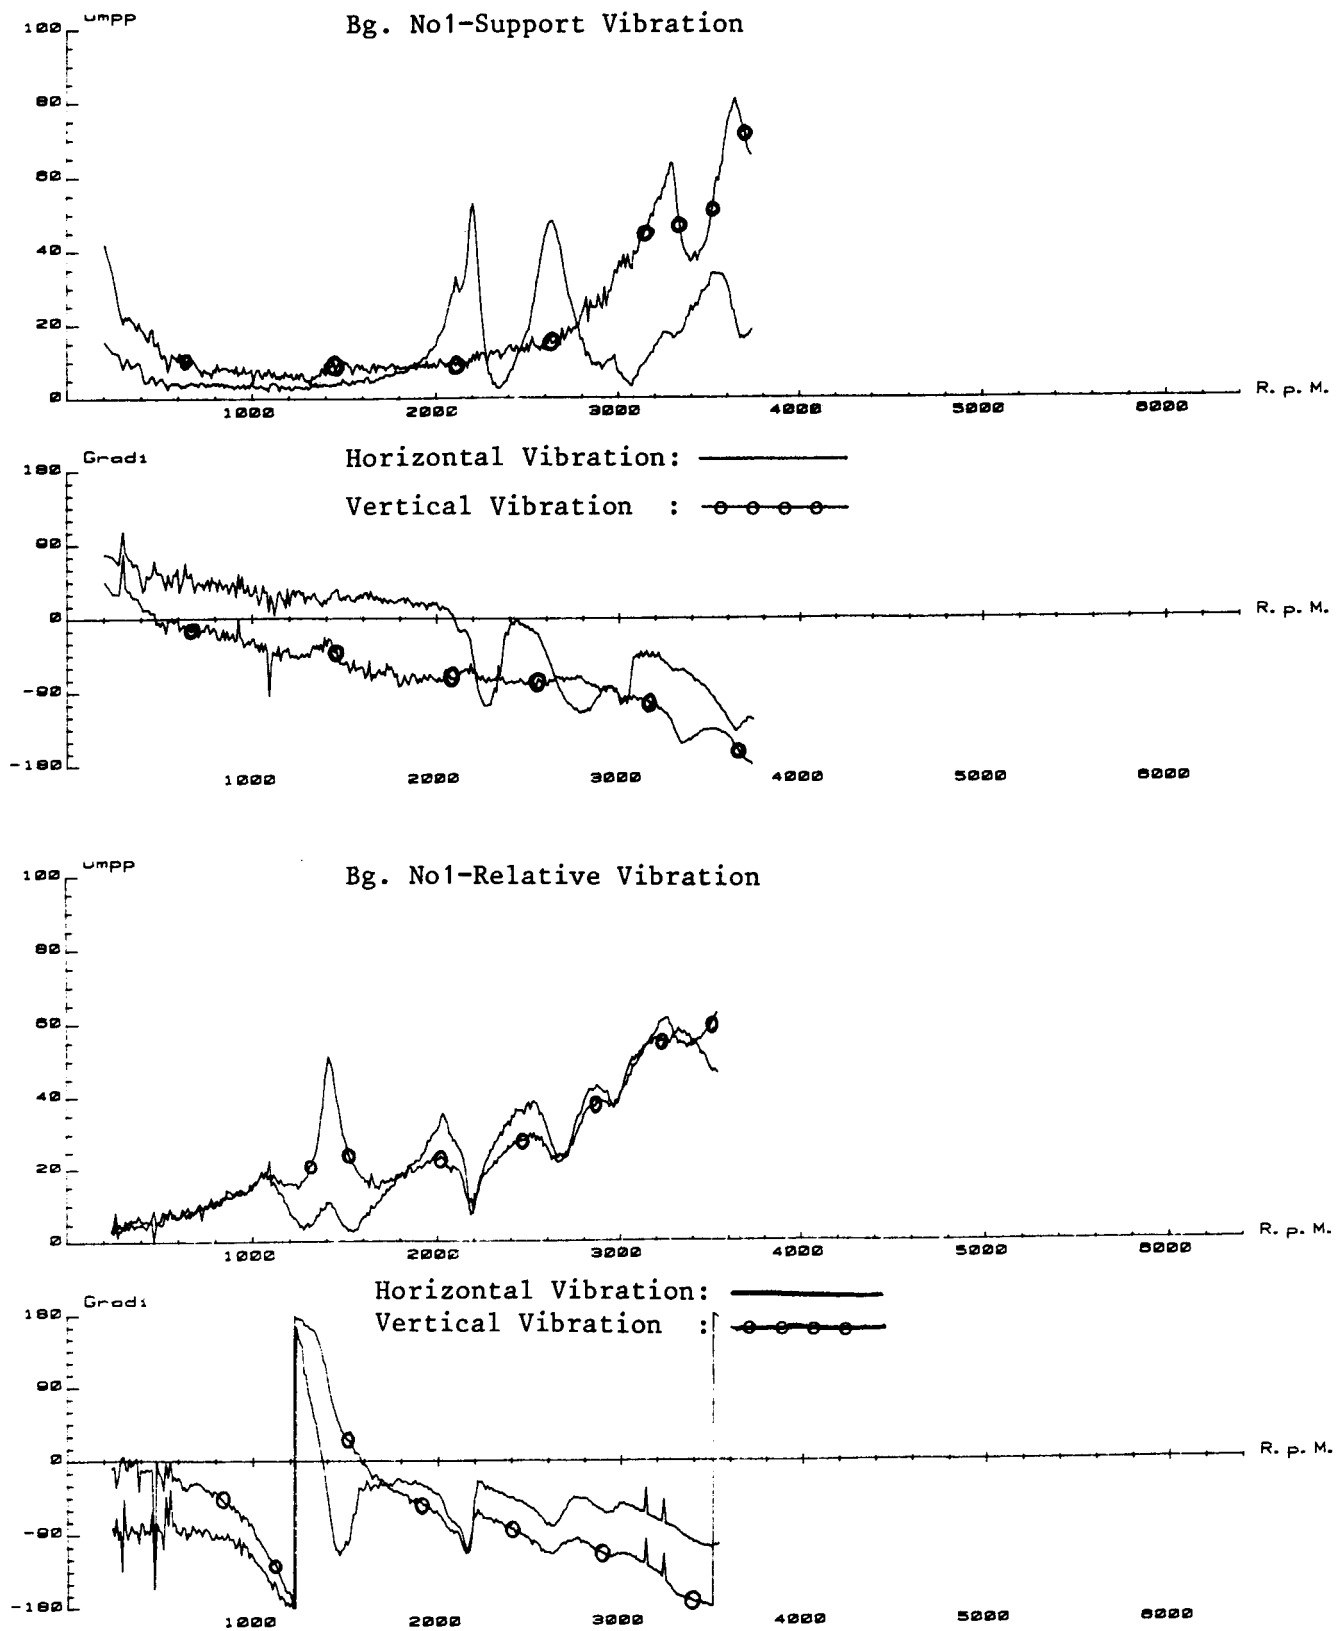
Fig.1 - Speed transient of the alternator rotor

speed of the rotor was at about 1070 r.p.m. in the horizontal and at 1420 r.p.m. in the vertical plane. A 2nd critical rotor speed was most probably at about 3250 r.p.m. in the horizontal and quite near the maximum speed in the vertical plane. Other resonances might be attributed to flexibility of the supports and foundation and, for all of them, the phases indicated a 2nd vibration mode above 2000 r.p.m. (Fig. 1).

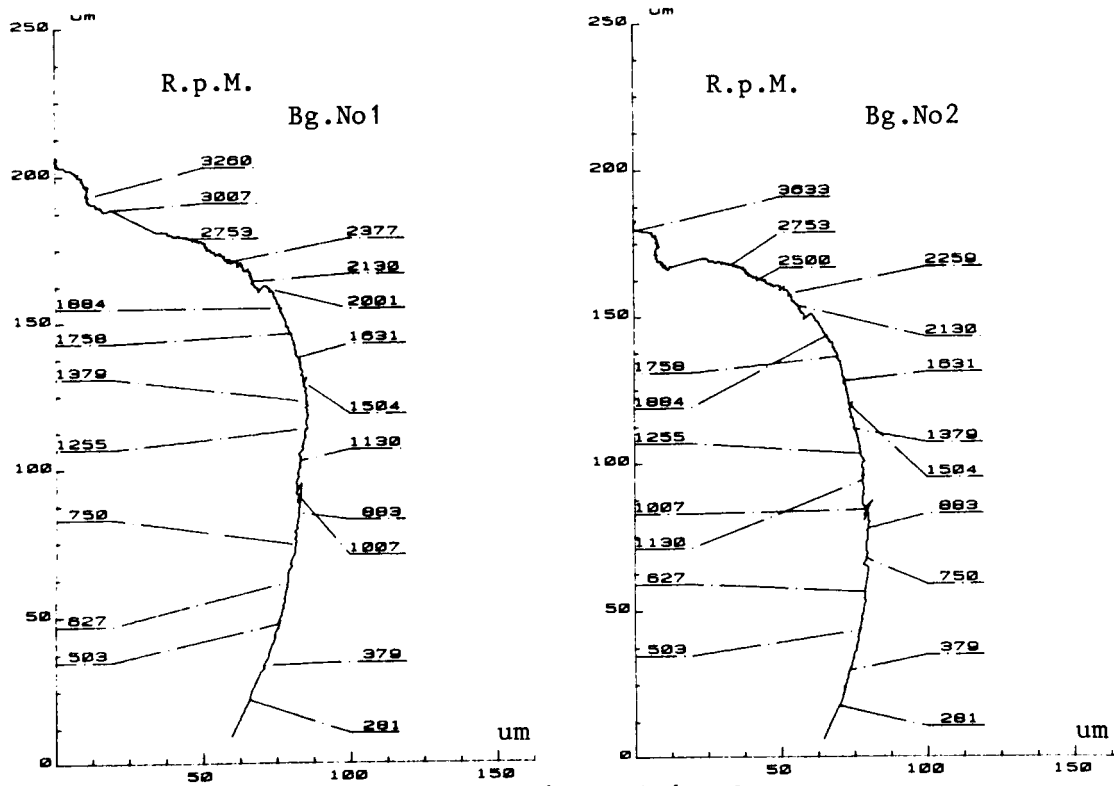
Fig. 2 - Center loci of journal in alternator rotor bearings

-The centre loci of journal in bearings showed that, at the higher speeds, the shaft moved strongly towards the bearing centre (Fig. 2).

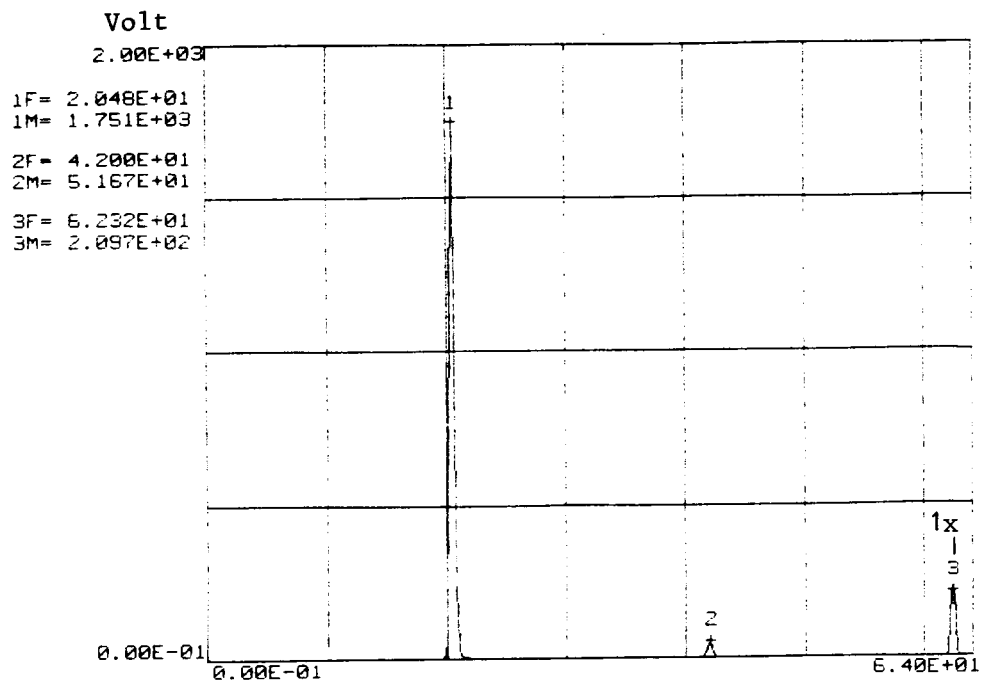
Fig. 3 - Spectrum during the instability of the alternator rotor

-In the presence of the phenomenon, the high vibration levels were mainly determined by a sub-synchronous vibration component at 20.4 Hz (1250 r.p.m.), while running speed frequency was 62.4 Hz (3750 r.p.m.). Maximum amplitude was reached by relative displacement in the horizontal plane and was of about 650  $\mu$ mpp, very close to total bearing clearance at the design stage. A number of much smaller harmonics of that component were also found and were considered to be due to non-linear behaviour of the oil film (Fig. 3). Though it almost coincided with 1/3 of the running speed, the frequency of the sub-synchronous component was considered as corresponding to excitation of the first critical speed of the rotor in those conditions.

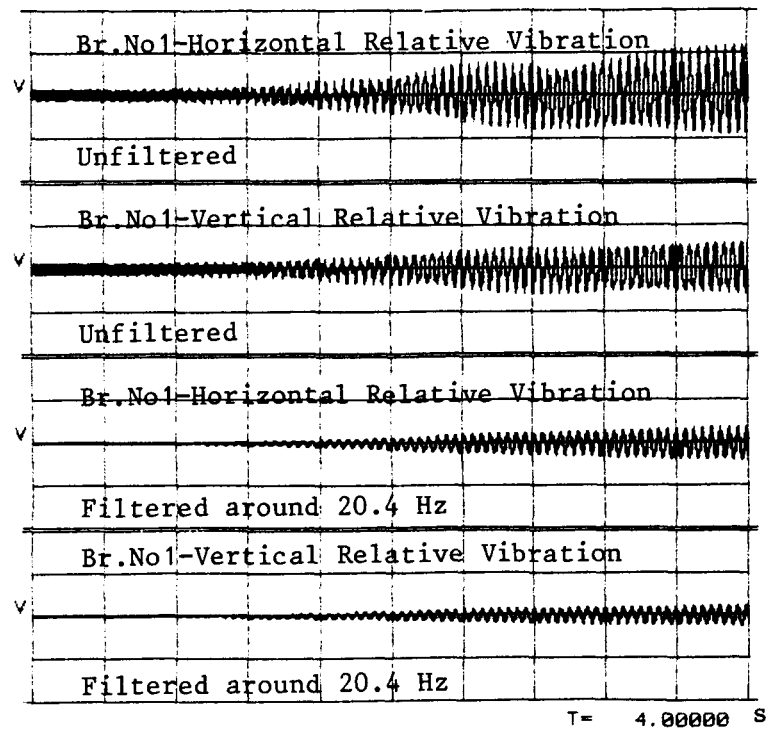
Fig.4 - Development of the instability on the alternator rotor

-When filtering signals around the sub-synchronous component at 20.4 Hz, it was observed that the growth of these vibrations was rather slow and during some cycles they even kept stable (Fig. 4). The expansion coefficient, equivalent to a critical damping coefficient for the introduction of energy, was found to be equal to 0.005, taking into account the logarithmic increment. The orbits showed that the journal followed a forward whirl. Figure 5 shows a subsequent series of orbits.

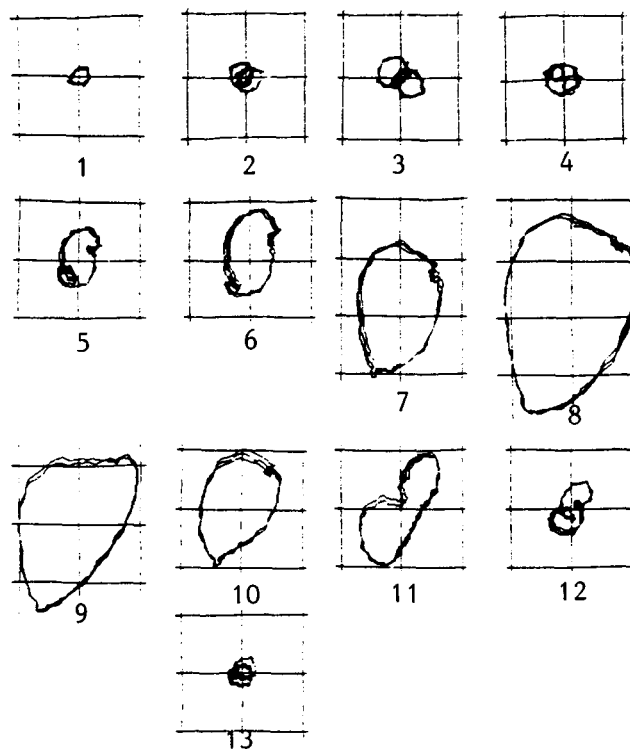
Fig.5 - Journal orbits in bearing No1 during the instability of the alternator rotor

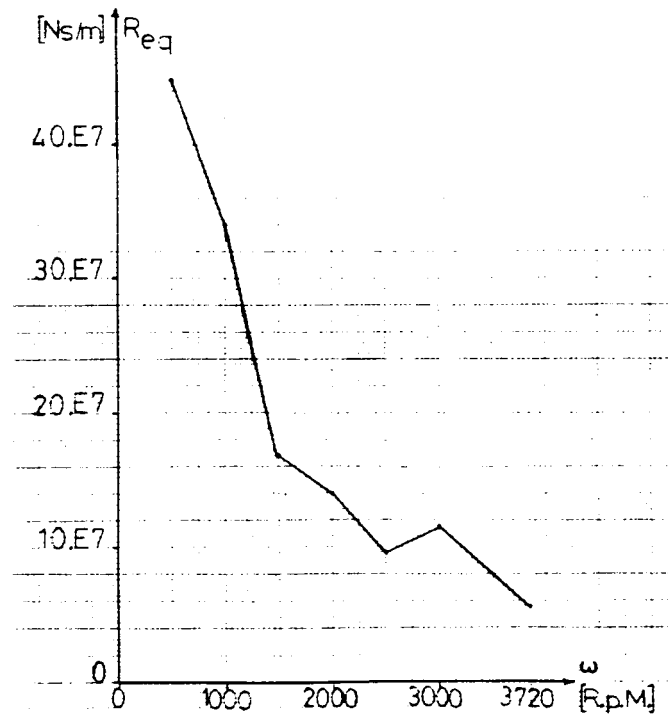
Fig.6 - Equivalent damping coefficient at different speeds of the alternator rotor

Lastly, for a number of speeds, a coefficient  $R_{eq}$ , proportional to the energy  $E_d$  dissipated in the oil-film bearings during one orbit of revolution, was calculated. The coefficient was obtained by dividing  $E_d$  by the mean square value of the relative vibration amplitudes in each bearing multiplied by the frequency of rotation and adding together the results for all bearings, according to the following formula:

Thus,  $R_{eq}$  has the dimensions of a damping coefficient. The  $E_d$  terms were calculated by taking into account the theoretical values for the oil-film coefficients and the experimental values for the relative vibrations. In spite of a marked decrease with speed (Fig. 6), the coefficient was always positive, even at maximum speed.

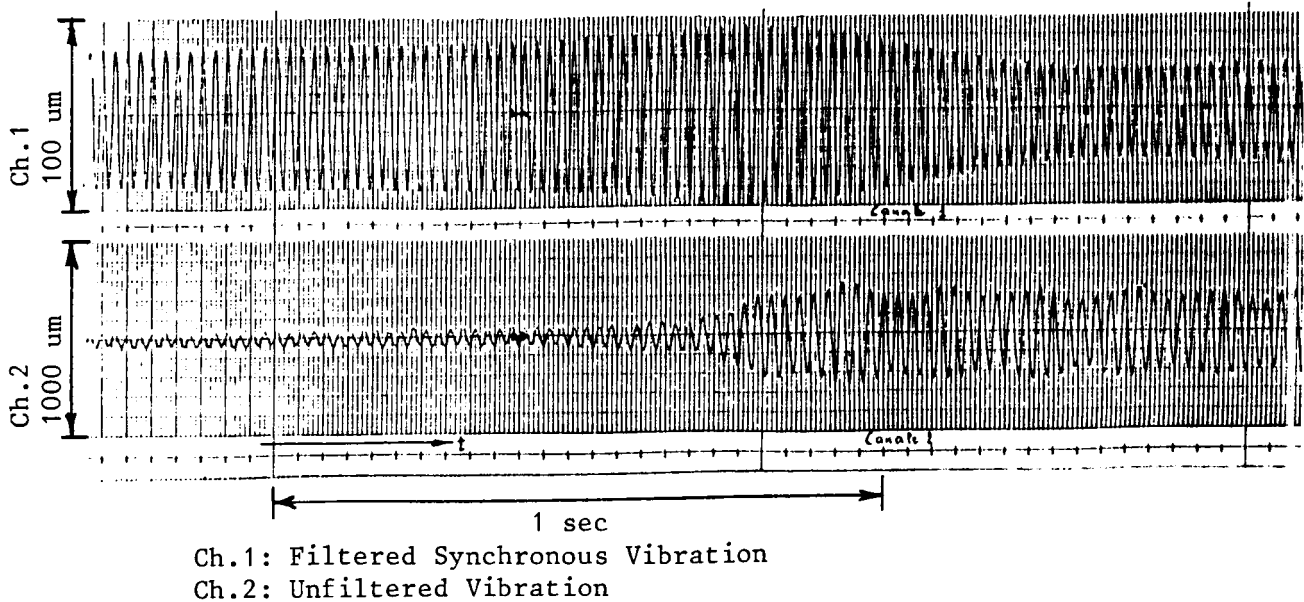
Fig. 7 - Development of the instability in the boiler feed-pump

- The instability developed in no more than 10 cycles and, once fully established, the vibration was not steady (Fig. 7).

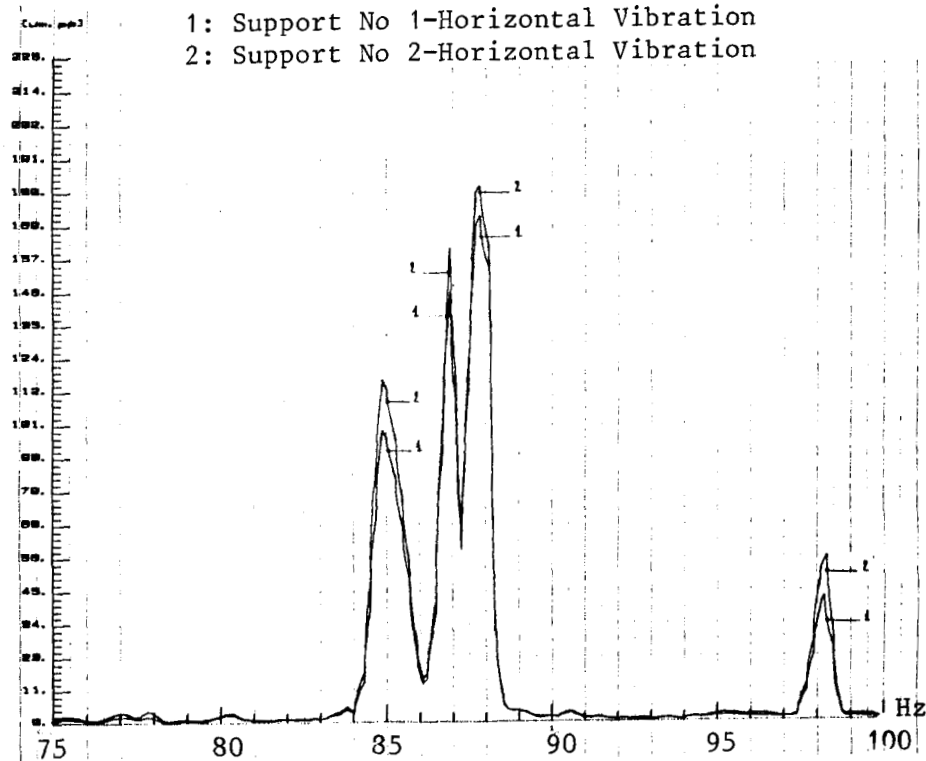
Fig. 8 - Typical spectrum analysis during the instability of the boiler feed pump

- Spectrum analysis during the instability indicated that, in such conditions, the vibration was mostly determined by a sub-synchronous component whose frequency ranged from 0.85 to 0.97 of the running speed (Fig. 8, 9). The frequency of this component was not related to the rotational frequency, nor to the pressure or to the flow rate, as evidenced in figure 8, where the spectrum, obtained by a peak-hold average on only one time record 5 seconds long, showed 3 sub-synchronous components with different frequencies.

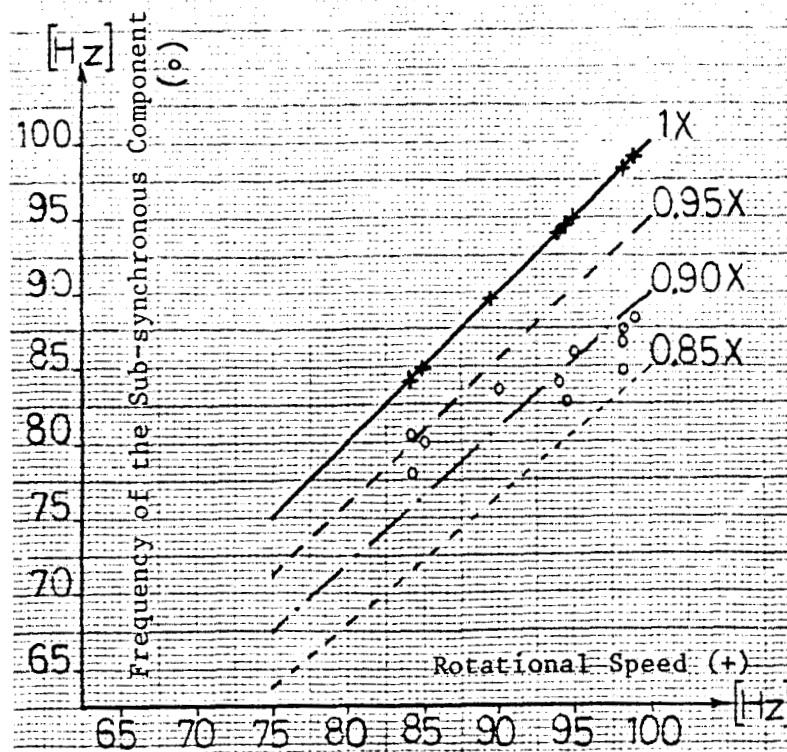
Fig. 9 - Frequency of the sub-synchronous component versus the rotating speed in the instability of the boiler feed-pump

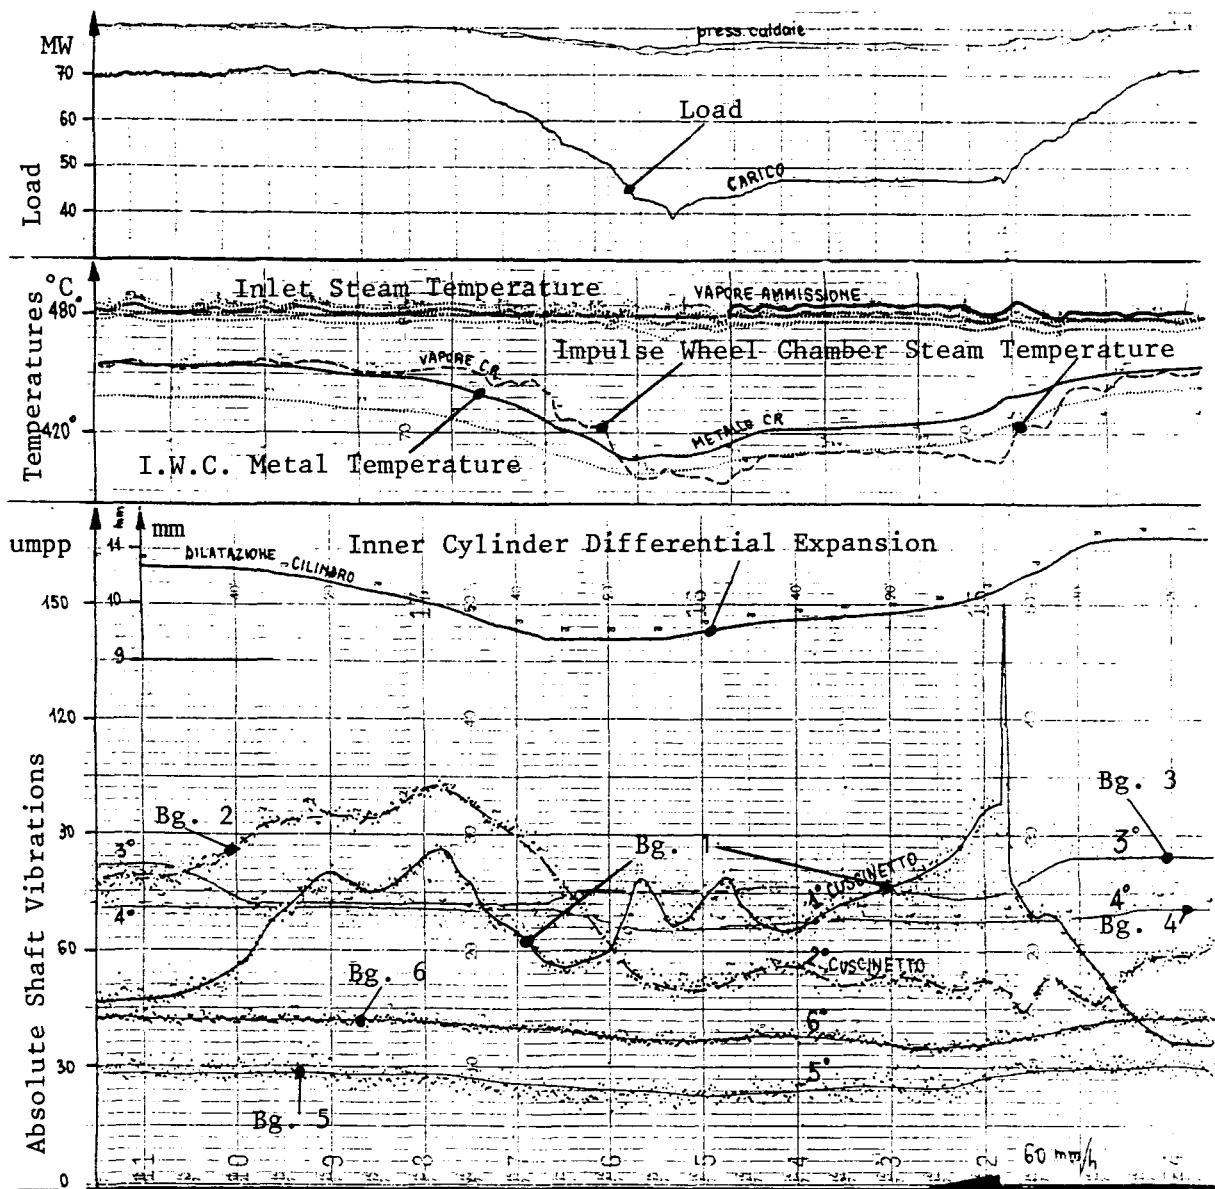
Fig.10 - Surveillance system recordings during a load transient of the H.P. turbine

Two months after overhaul, the H.P. rotor showed a sudden increase in vibration in bearing No 1, after load reductions during normal operation. Surveillance instruments showed the phenomenon as a sharp peak in the overall absolute shaft vibration of that bearing only, the other bearings being apparently unaffected (Fig. 10). Moreover, the phenomenon only lasted a few minutes, then disappeared without tripping the unit. It was preceded by a continuous increase in vibration level at the same bearing, starting with the load reduction

transient and in good correlation with metal and steam temperature changes in the impulse wheel chamber. It is worth adding that load reductions were achieved by partialization of steam admission.

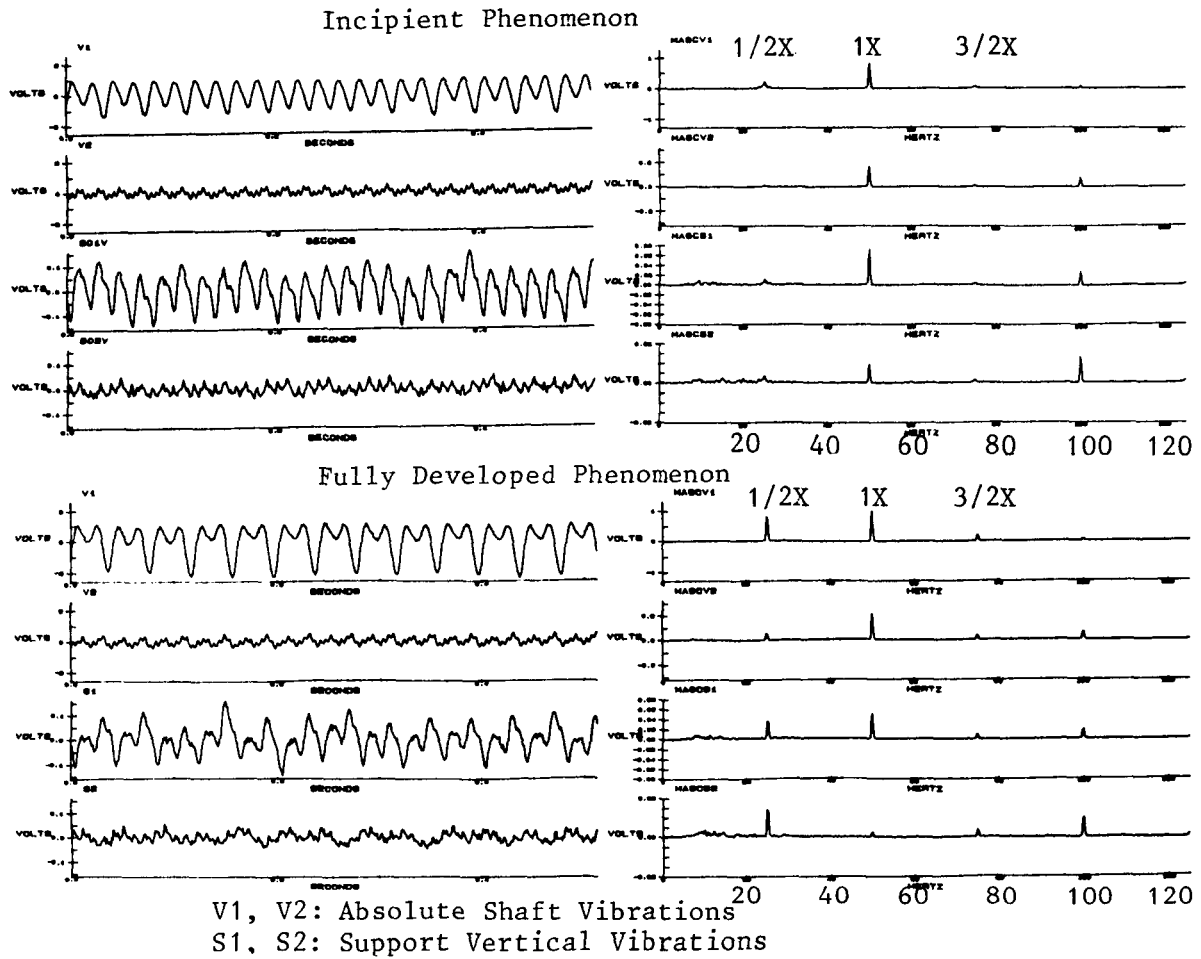
Fig.11 - Time records and spectrum analysis in the instability of the H.P. turbine

A few tests were devised with the machine still in service. First of all, the operation sequence that had given rise to the phenomenon (load reduction from 70 MW to about 47 MW) was repeated, being careful to start from and to arrive at steady thermal conditions. In fact, the phenomenon appeared again, in almost the same way as shown in figure 10. Frequency analysis indicated that, during the first phase of load and thermal transient, vibration rises at bearing No 1 were caused mostly by a fundamental component of the signal, and 2nd harmonic variations appeared after a certain vibration level, probably due to non-linearities in the oil film. When the fundamental component arrived at about 90  $\mu\text{mpp}$  a sub-synchronous component became visible; but it was not yet stable and it appeared and disappeared suddenly between one series of orbits of revolution and another. With a further increase in the fundamental component over 100  $\mu\text{mpp}$ , the phenomenon continued to be present and the sub-synchronous vibration stabilized on a definite value (Fig.11). Values as high as 200  $\mu\text{mpp}$  were read for this component. In any case, its frequency was 25 Hz, exactly half the frequency of the running speed. Moreover, higher harmonics at 75 and 125 Hz were present, the others, at 50 and 100 Hz, being hidden in the fundamental and 2nd harmonic components. The 25 Hz component was very low for the absolute shaft vibration at bearing No 2, while it was marked on both supports of bearings No 1 and No 2. Finally, when the thermal transient died out and the vibration decreased to below the above-mentioned levels, the sub-synchronous component disappeared.
